TO: All Homeowners

It has been reported to the Board of Directors that during the heavy rains that we experienced in the late fall of 2018, several homes built by DR Horton began experiencing water leaks below the upper floor concrete patio slab. The leaks, over a period of time, visibly penetrated walls and ceilings below the general locations of the concrete patio slab edge. Given the limited information available at the time of the reports, the Association took proactive steps to protect property and retained Blue Nail Enterprises, a general contractor and roofing company, to inspect these homes and attempt to determine the source or cause of the leaks, and to recommend a solution to mitigate the leaks. The Association also asked Blue Nail Enterprises to inspect the upper floor concrete patio slabs at several homes built by DR Horton throughout the community that had *not* experienced water leaks.

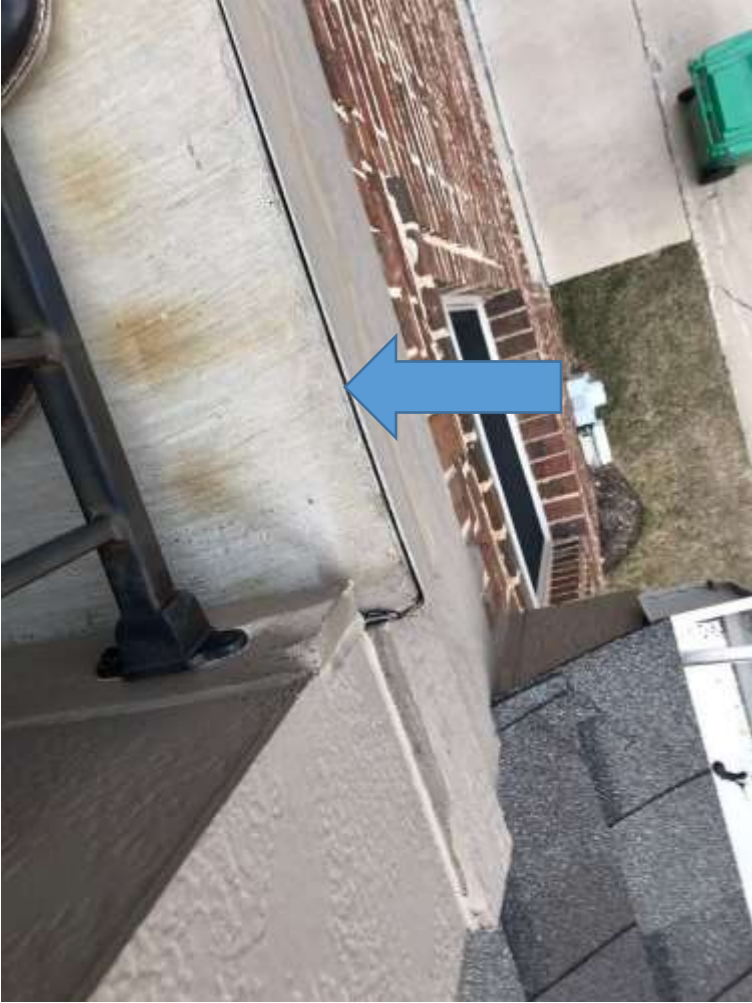
Blue Nail Enterprises reported that the leak was caused when water seeps between the upper floor concrete patio slab and the metal edging on the outside of the patio slab at the edge of the building (see enclosed picture.) It cannot be determined, at this time, whether the source or cause is due to inadequate architectural design or construction defect. Blue Nail Enterprises believes that the water seeps between metal edging and patio slab and eventually works its way inside the home.

Blue Nail Enterprises was able to recommend a repair that appears to prevent water from seeping under the concrete slab in the homes that reported a leak. The repairs entail applying a silicone sealer in every location along the upper floor concrete patio slab where it appears that water may enter the home. Each home may require its own unique recommendation to repair the issue.

Blue Nail Enterprises has provided a quote of approximately \$600 - \$800 per home to seal the areas described in this memo for a remedial repair to exterior only. If interested, Blue Nail Enterprises can be contacted directly by calling 469-726-2176. Homeowners can also utilize their own contractor to make the repairs.
